# Thermal In-Situ Scheme Progress Report for 2016 Japan Canada Oil Sands Limited Hangingstone

### **Approval No. 8788 (Demonstration Project)**

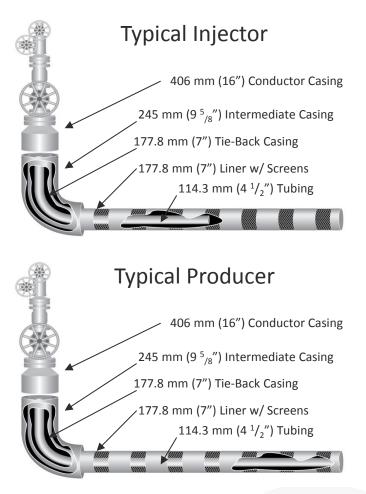
### SAGD Well Completions

Tie-Back	Liner Size		Screen Type			4-1/2" Tubing	
Wellpair	Yes/No	7"	8-5/8"	Mesh- Rite	Wire Wrap	Seamed Slotted Liner	To Mid	To Toe
А	Yes	Р	-	VP	-	-	-	Р
В	Yes	٧P	-	-	٧P	-	-	VP
С	Yes	٧P	-	-	VP	-	-	VP
D	Yes	٧P	-	Р	1	-	-	VP
E	Yes	VP	-	VP	-	-	-	VP
н	Yes	Р	1	-	VP	-	-	VP
1	Yes	VP	-	-	VP	-	1	P
J	Yes	٧P	-	-	VP	-	1	P
к	No	VP	-	-	VP	-	1	P
L	Yes	VP	-	-	VP	-	1	P
м	Yes	VP	-	-	VP	-	1	P
N	Yes	٧P	-	-	VP	-	1	P
0	Yes	VP	-	-	VP	-	-	VP
Р	Yes	٧P	-	-	-	VP	1	Р
Q	Yes	VP	-	-	VP	-	1	P
R	Yes	٧P	-	-	I	P	1	P
S	Yes	Р	1	-	-	VP	-	VP
Т	Yes	Р	1	-	-	VP	-	VP
U	Yes	Р	1	-	-	VP	-	VP
V	Yes	Р	1	Failed Liner	- 4-1/2"WWS	VP	-	VP (2-7/8")
w	Yes	Р	1	-	-	VP	-	VP
х	Yes	-	VP	-	-	VP	-	
Y	Yes	-	٧P	Failed Liner - 5-1/2"WWS		٧P	-	1
Z	No	Р	1	SCVF- 7" Cerr	nent to Surface	٧P	-	1

- 1999-2004 MeshRite/wire wrap Limited technology available for "SAGD" applications
  - Isolated cases of sand production
- 2005-2010 Slotted Liner Commercial emergence of technology, lower cost alternative
  - Good sand control
  - High pressure drops
